ST. STOŠIJA CHURCH, PUNTAMIKA ZADAR - CROATIA

Management handbook

03/2020

Management plan for church of St. Stošija, Puntamika (Zadar) was compiled by ZADRA NOVA and City of Zadar as part of the activities of the RUINS project, implemented under Interreg Central Europe Programme 2014 – 2020.

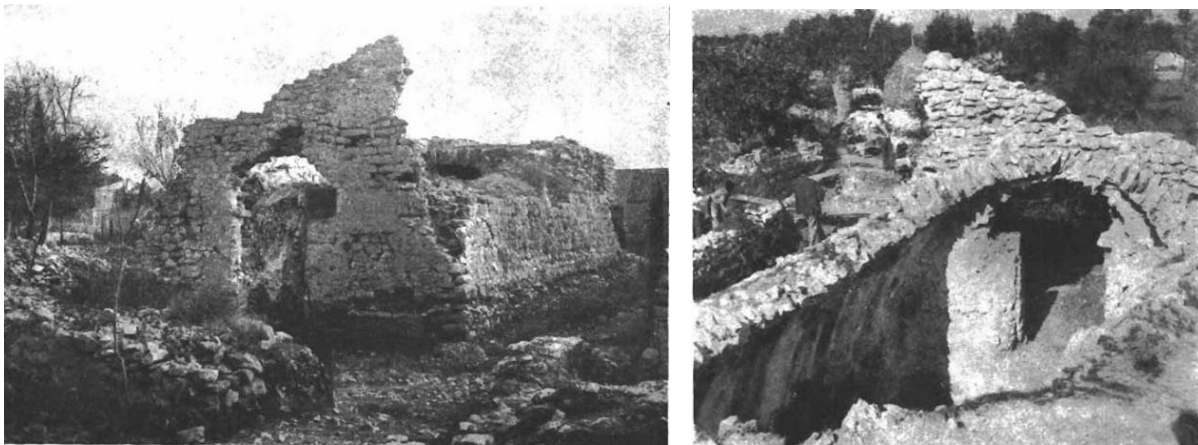
Figure 5, 6. Ruins of St. Stošija (1952)

In the time the church was researched in 1952, the surrounding land was slightly elevated and it was concluded that the foundations of the outer walls are quite shallowly buried. In some places the stone nerve was only 20 cm below the surface. Following the outer perimeter of the church, several graves have been found. They were archaeologically researched, photographed and documented. At the same time, the interior was cleared from stones, dirt and ground, and the recent walls erected for the purpose of everyday use for economic purposes were removed. Thus, the original floor of the building was found, which was then cleaned. Luckily, it was shown that it had been preserved in almost its entire surface. It was more difficult to clear and identify the remains of the walls of the ancient antique layer. Finally, works undertaken during the research showed the results of several different phases, all of which were documented and later interpreted.

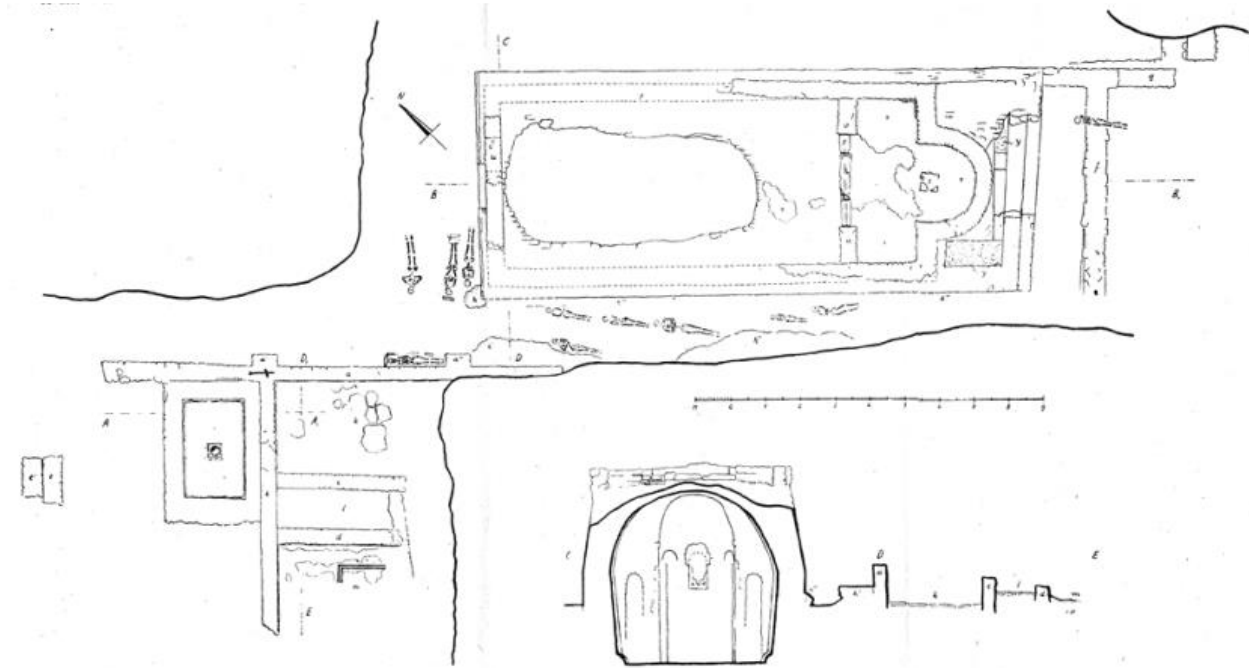
Figure 19. Plan and cross-section of St. Stošija – showing results of the research in 1952

other. The lower church was created by the adaptation of a Roman cistern, while the upper one was built on the cistern itself.

The perimeter walls of the cistern consist of two walls, adjacent to each other but unrelated, and of different construction. The exterior is made of pressed stone blocks of medium size, layered and plastered together. The foundations of the walls do not go to the same depth on the outer and inner faces.

The apse has trapezoidal floor plan and is lined with a hemisphere. The transition from the quadrilateral base to the semicircle was made using shallow tromps that remained well preserved. As no traces of the newer floor were found, it is likely that the floor of the cistern also served for the church. The same was the case with access.

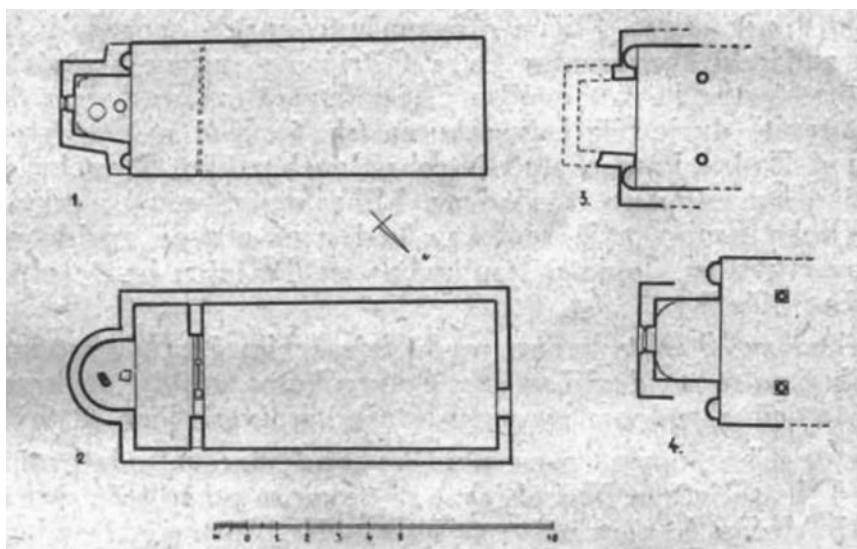
Figure 23. Plans - St. Stošija, lower church; St. Stošija, upper church, St. Lovro, Zadar – the altar space, St. Barbara, Trogir – the altar space

The lower church, to the present knowledge, on the contrary does not exactly have an identical pair. There are comparative examples for particular sections, but not for the whole church. For example, the use of trompe in reduction is often reported in our pre-Romanesque architecture. The quadrangular apse with the tromps is thus found in Zadar in the church of St. Peter the Old, or St. Luke's on Lastovo.

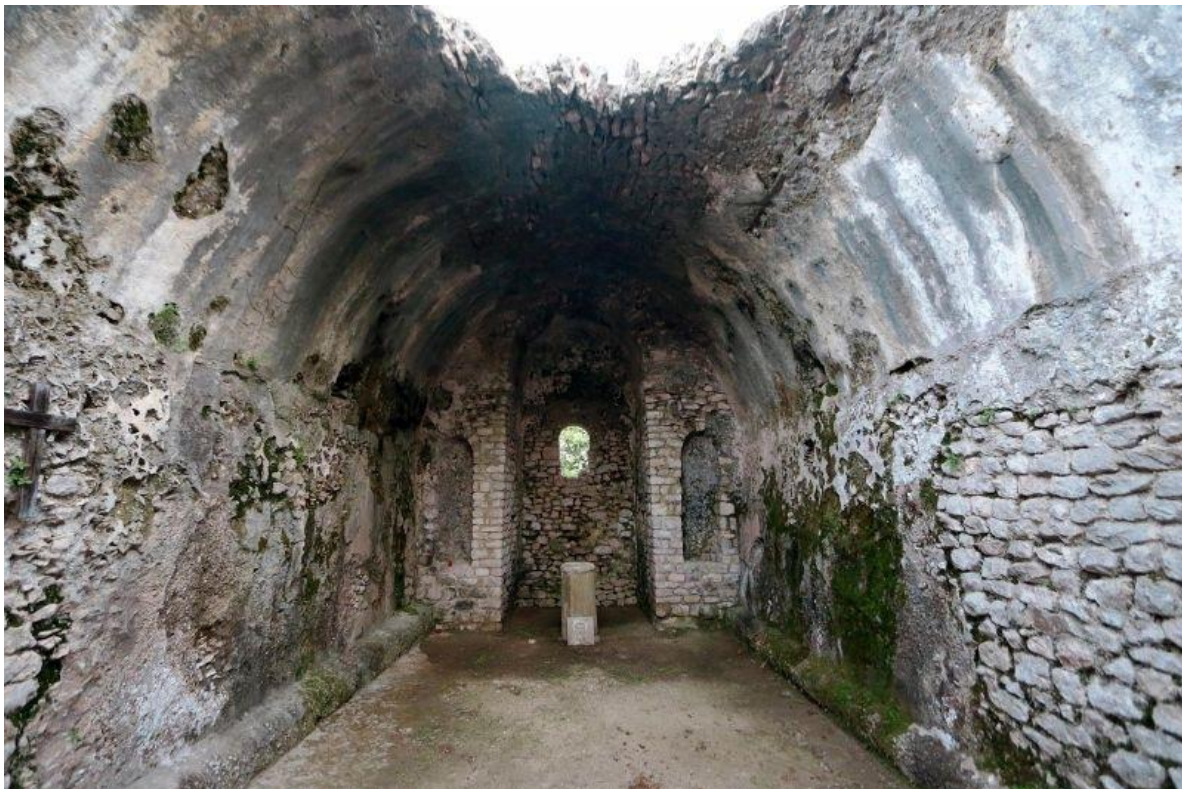
Figure 25. The church of St. Stošija, Puntamika

The condition of structural elements of St. Stošija, i.e. foundations, ceilings and the roof framework were improved in 1950s, after the first conservation and archaeological research was conducted. But today the construction is weak, water is being accumulated in space of the lower church, and the remains of the walls and chancel are suffering from decay due to atmospheric negative influences. Also, the vegetation and microorganisms that are living on different parts of the church walls, floor and next to the foundation, slowly but constantly destroy the mortar and the stone pieces and slabs, and there is visible widening of the existing wall-cracks as well as the new ones occur constantly.

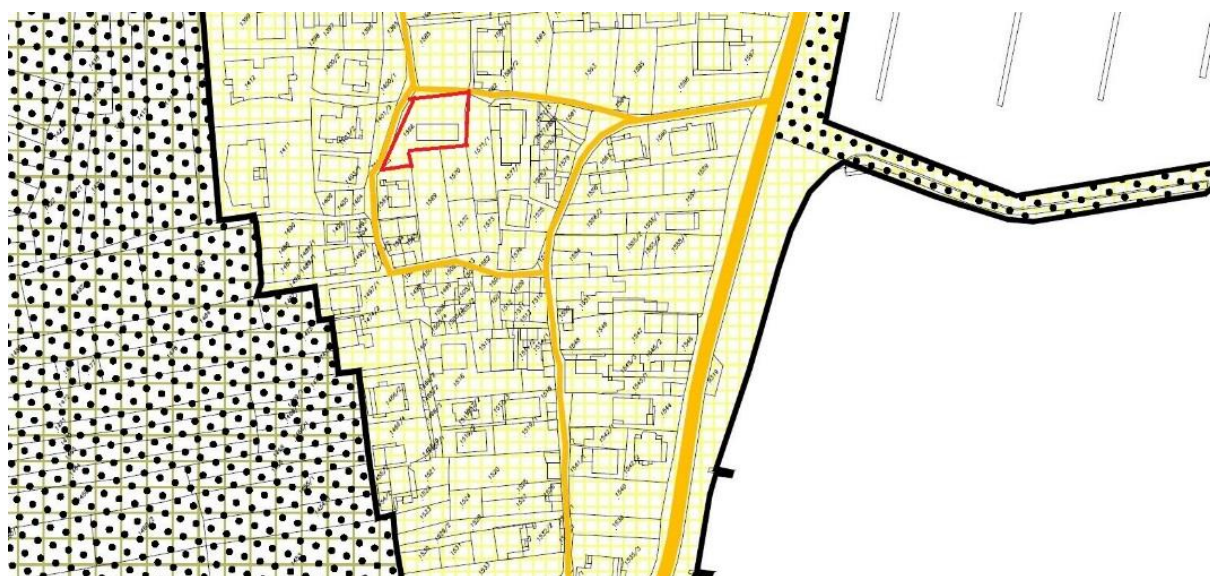
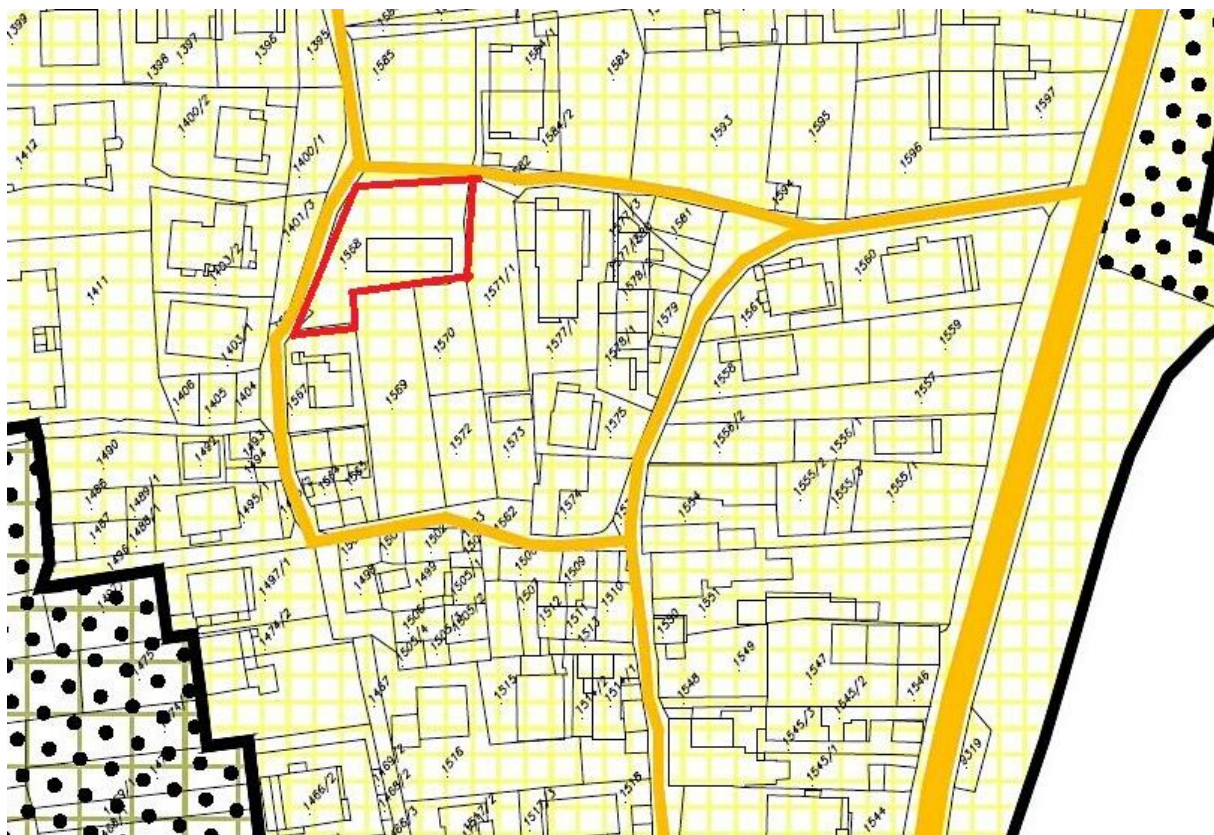
Figure 34. Excerpts from the Spatial Planning Plan of the City of Zadar, supplement form 2016 (Official Gazette 13/2016): graphical presentation of the Puntamika area, with the parcel of the archeological site „The remains of the St. Stošija church” bolded red. The yellow colour of the whole area signifies the following (according to the legend of the Plan): constructed part of the constructed area.

The archaeological site „The remains of the St. Stošija church” is included in the current urban-planning plan, the *Spatial Planning Plan of the City of Zadar, supplement form 2016* (Official Gazette 13/2016). The area around the archaeological site „The remains of the St. Stošija church” is marked as „the constructed part of the construction area” and therefore, no further urban-planning guidelines are added, meaning that by this plan a *status quo* is being preserved. The same plan contains a list of all the protected monuments and sites on the area of the plan, including the archaeological site „The remains of the St. Stošija church”. It is stated that all the works on the cultural heritage is under the jurisdiction of the regional Conservation Department in Zadar.

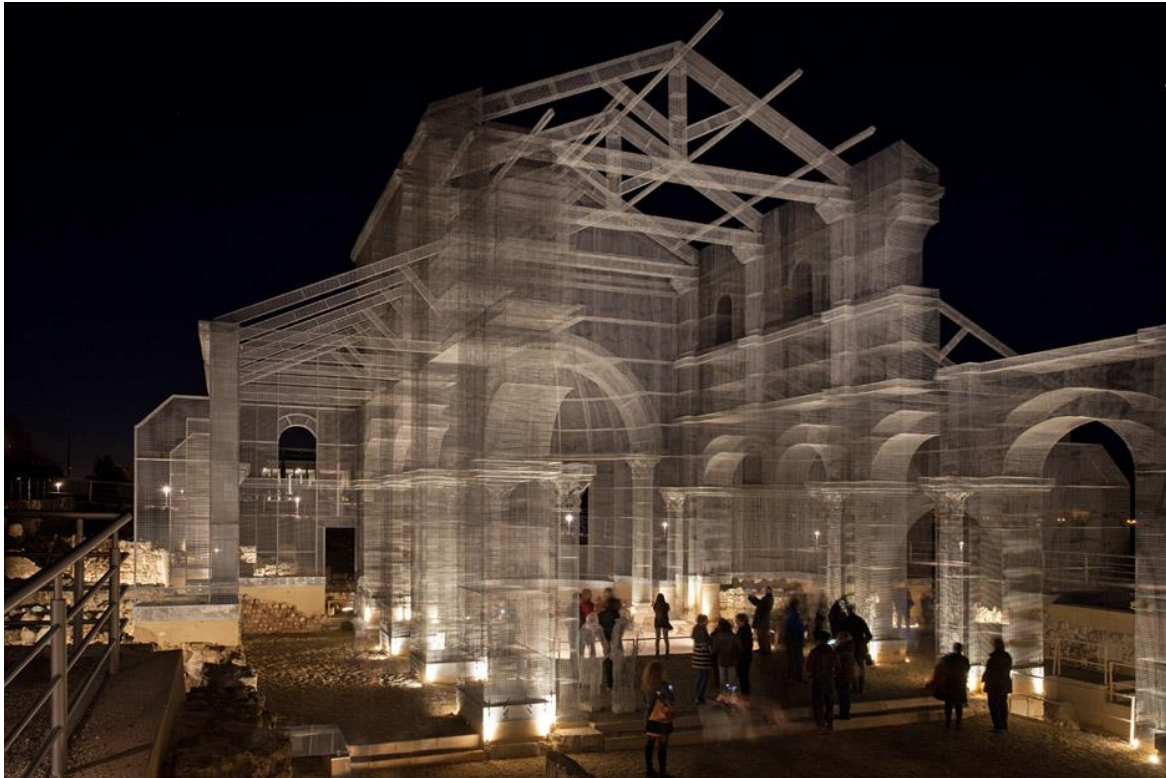
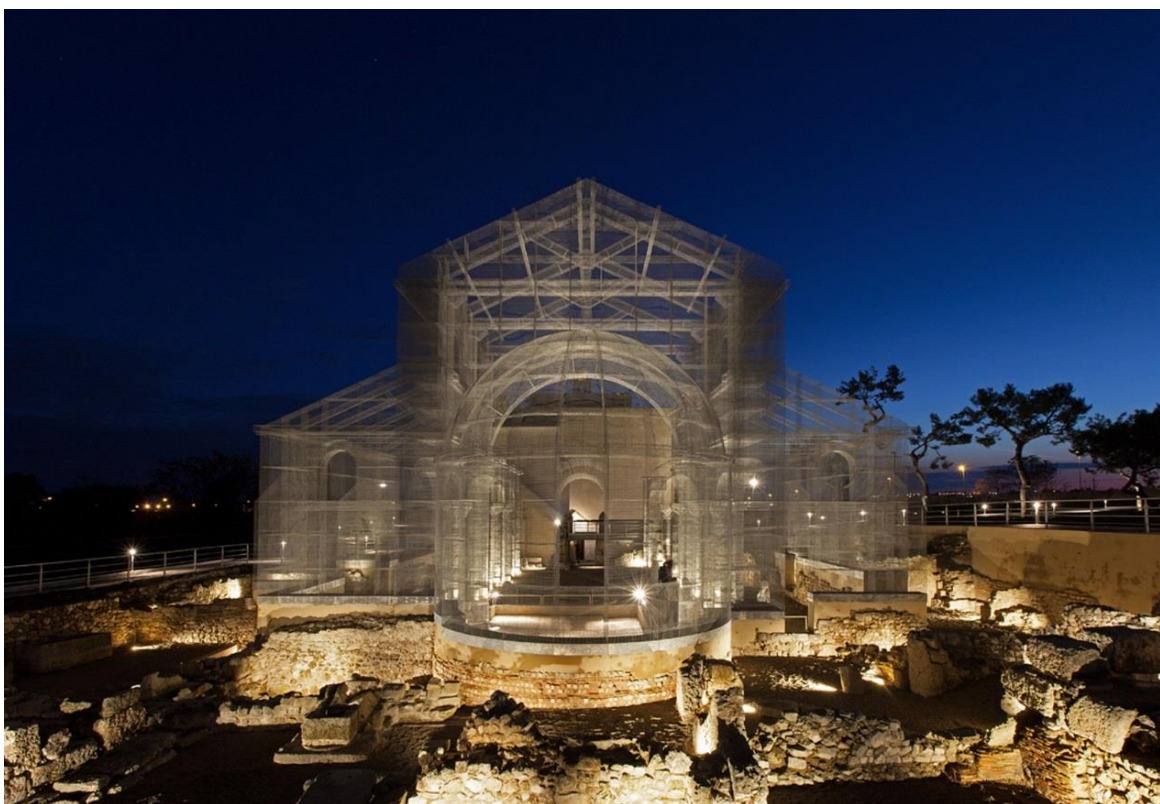
Figure 48-49. Italian artist Edoardo Tresoldi used wire to recreate an early Christian church on an archaeological site in Siponto, a port town in southern Italy.

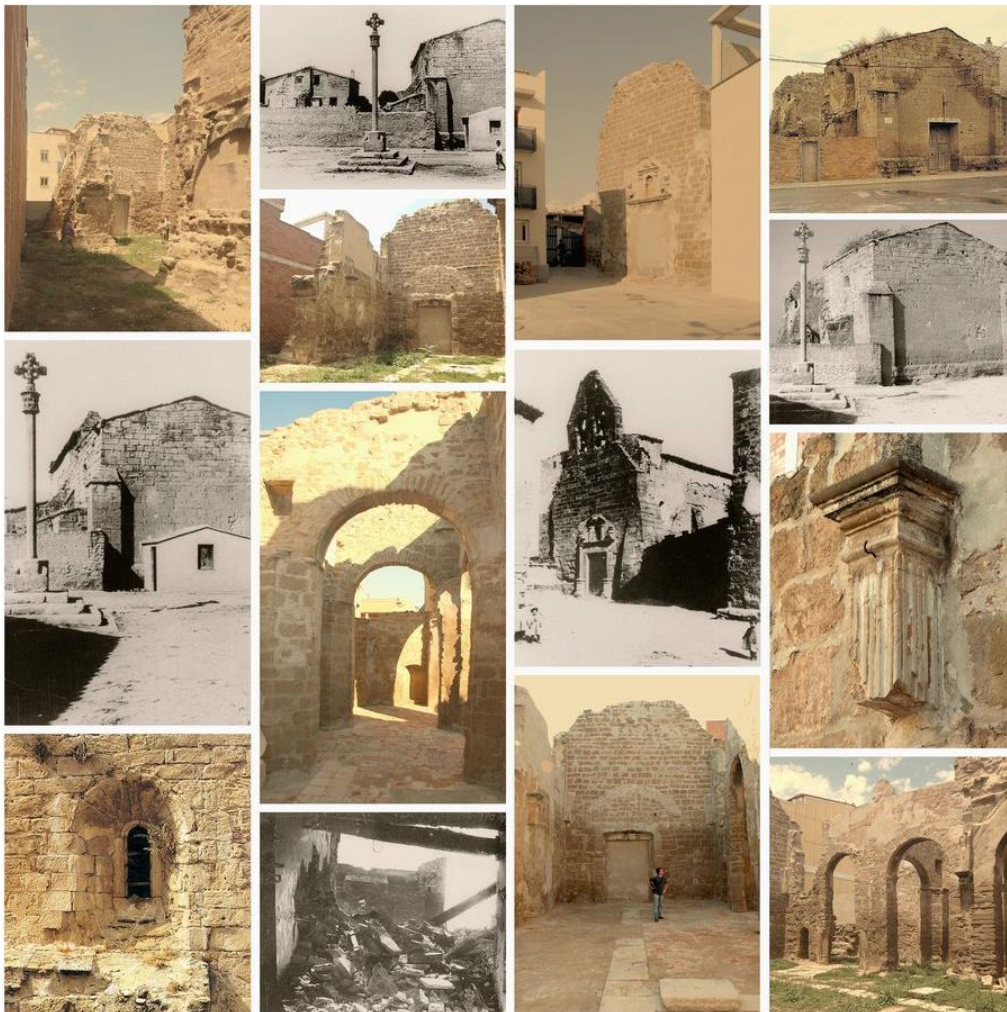
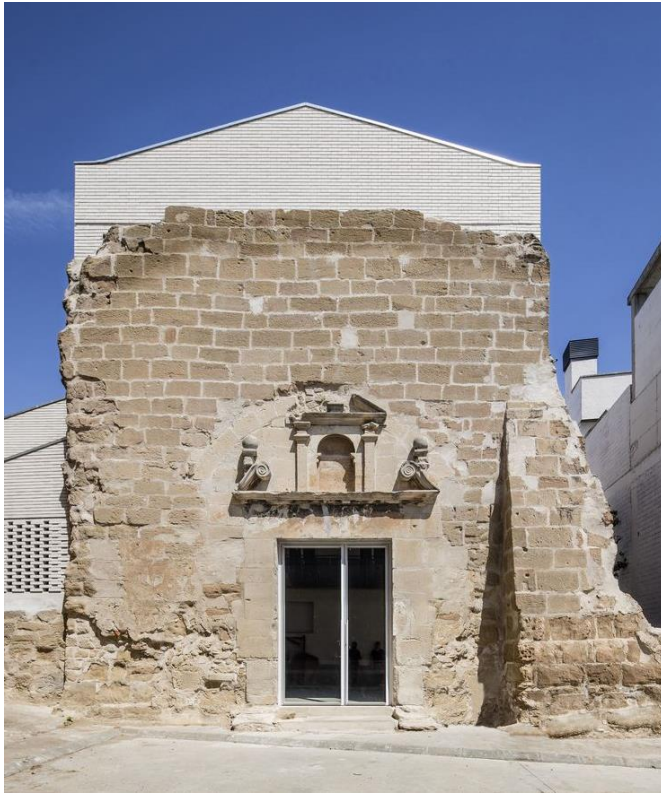
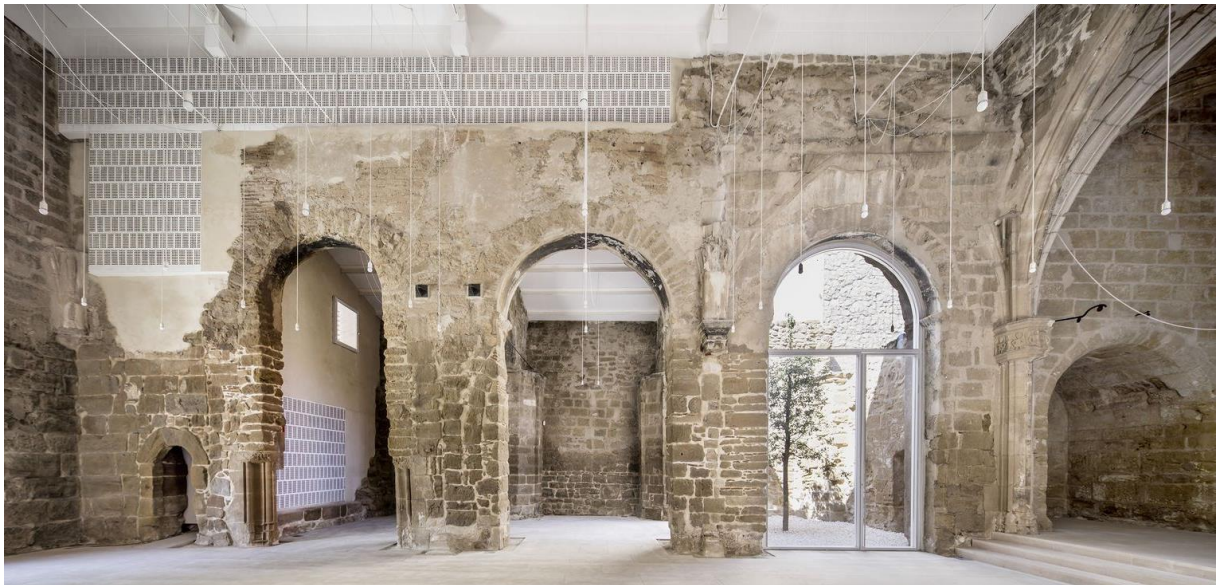
Figure 50-53. Reconstruction of St. Mary church, Villanova de la Barca

1. *Medieval church form 13 th century, dedicated to St. Mary, in Spanish city Villanova de la Barca was partially ruined in the bombardment, in the year 1936., during the Spanish Civil War. Only the sanctuary/apse, part of the northern wall and the western facade was preserved. The church was reconstructed in 2016.*

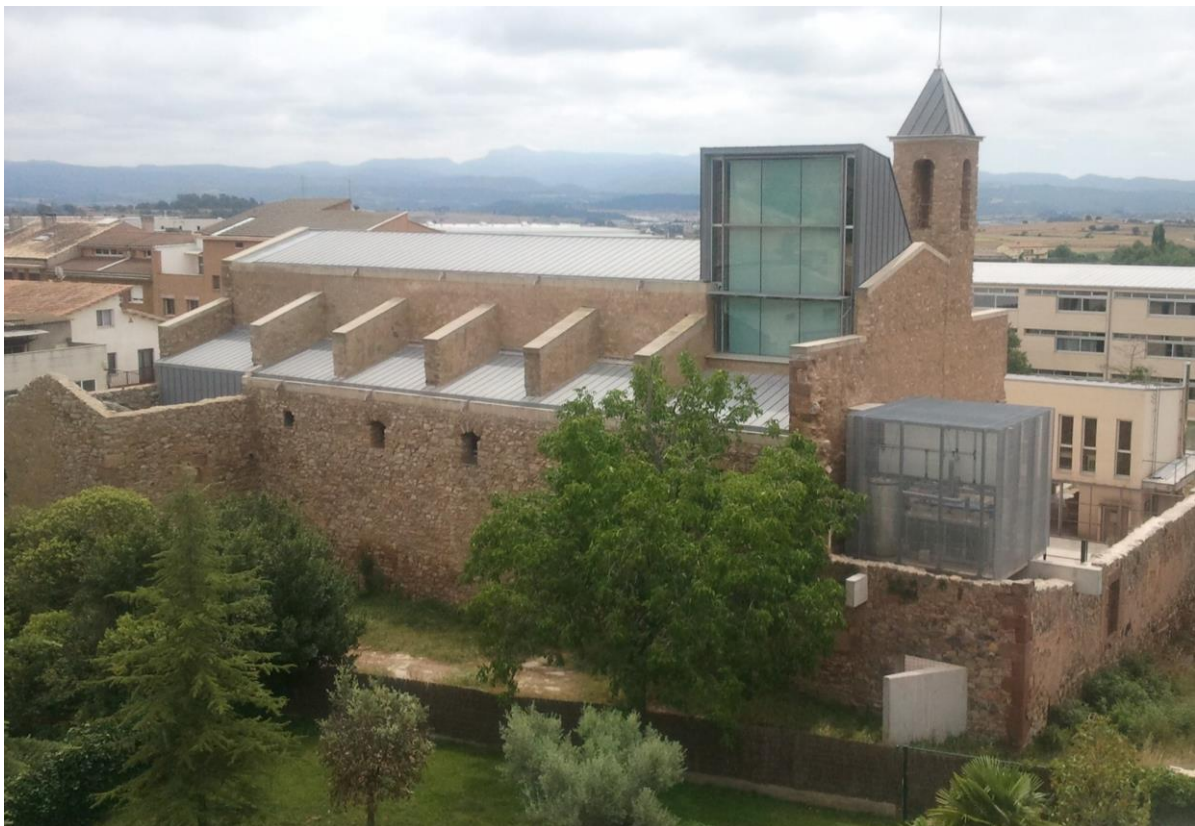
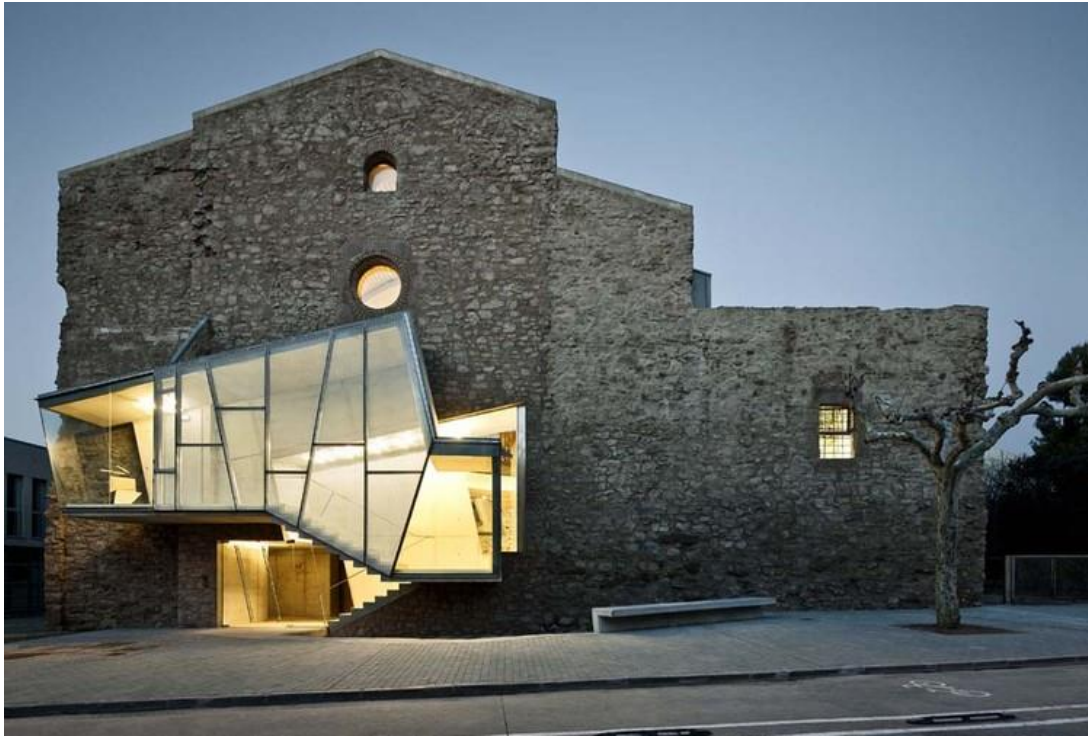
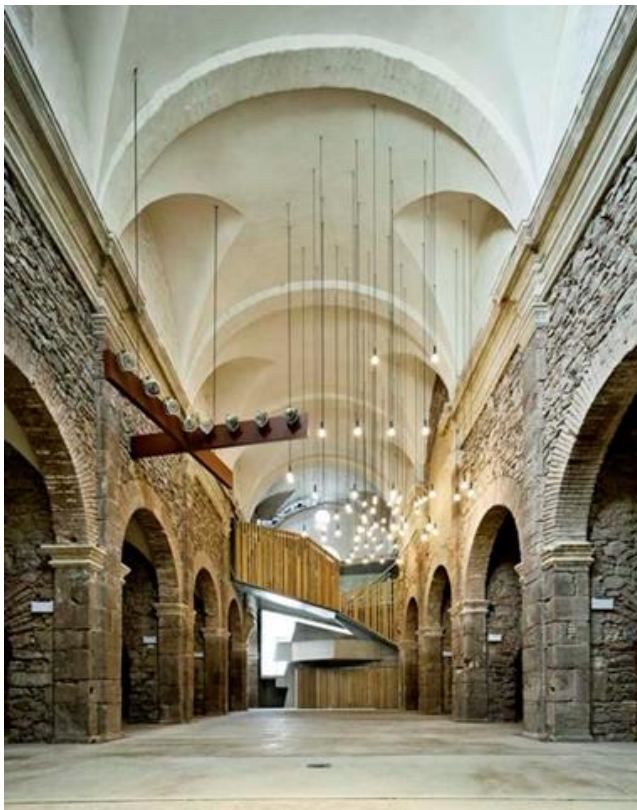
Figure 54-56. Auditorium in the church of Sant Francesc convent

2. The convent complex of Sant Francesc in the Spanish town Santpedor was built in the eighteenth century by Franciscan priests. The convent, which includes the renovated Church, was built between 1721 and 1729. The complex was used as a convent until 1835. In 2000 the convent, by then in ruins, was demolished by the state. Only the church and part of the perimeter wall of the convent remained standing, although in very poor condition. The renovation of the church occurred in 2003.
